Inspection Report

Mine Name: Torrey Buff and Lucero Red

Inspection Date: November 4, 2004

M/055/022, Lucero Red and Torrey Buff Quarries, Quality Building Stone

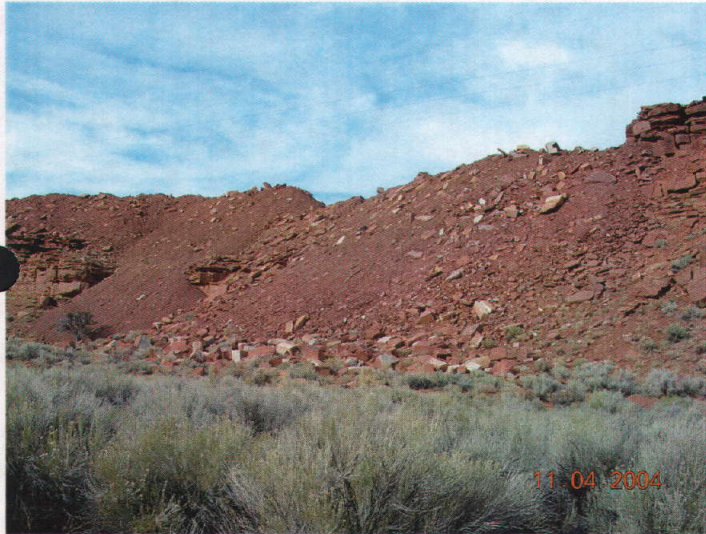
Photo 1. The outslope at the Lucero Red Quarry.

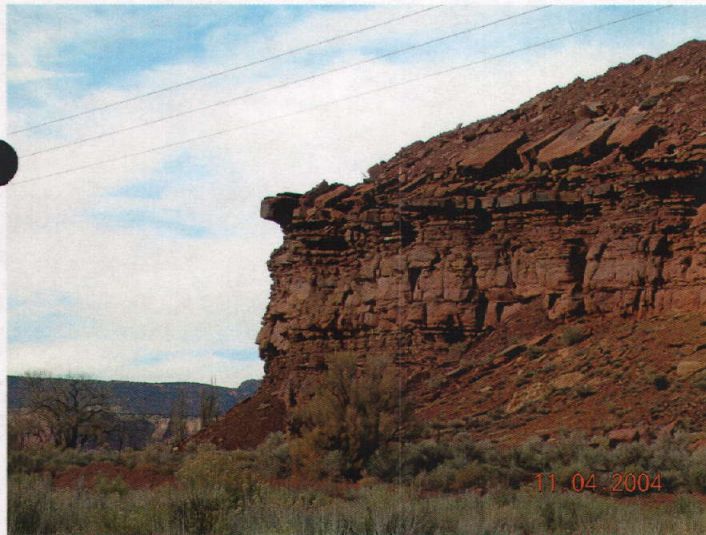
Photo 2. Another view of the Lucero Red outslope. Note the material at the base of the cliff on the left.

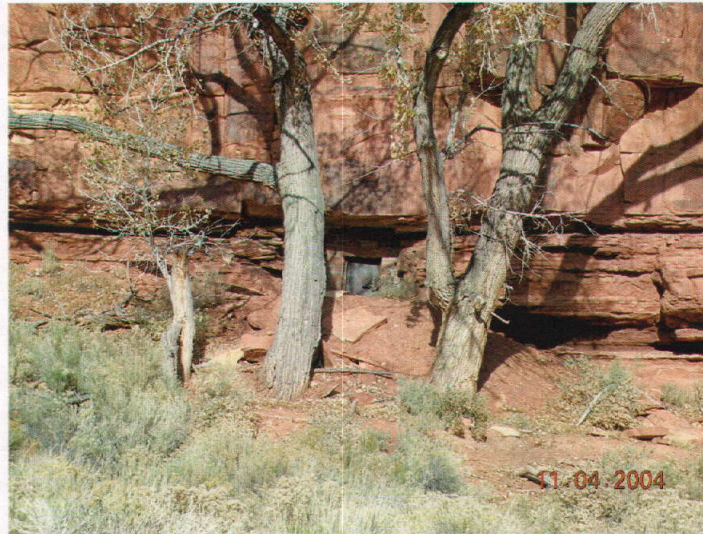
At the base of the cliff near the Lucero Red Quarry is an explosives magazine (Photo 3). I believe this may be the responsibility of Bruce Hansen.

Photo 3. Explosives magazine at the base of the cliff to the east of the Lucero Red Quarry.

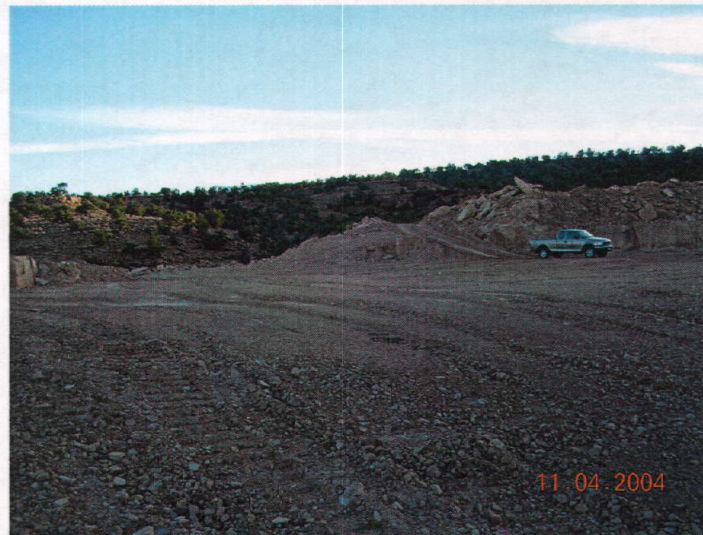
Photo 4. The top of the graded area at the Torrey Buff Quarry. The outcrops of this area are shown in Photo 9.

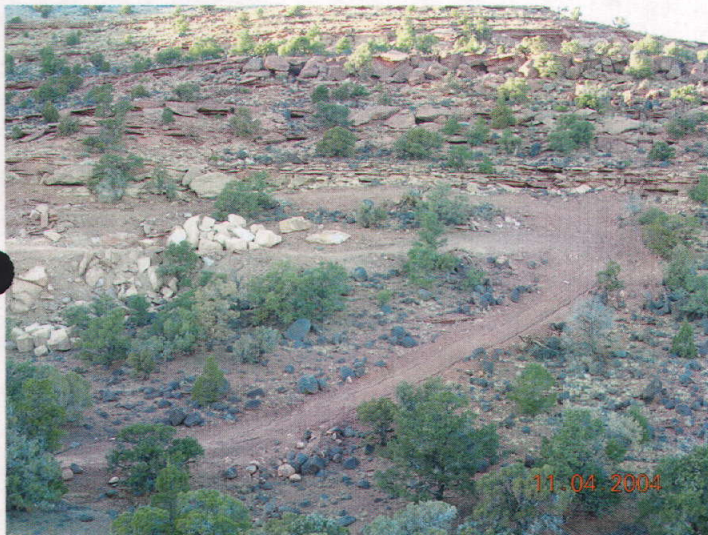
Photo 5. Area being reclaimed at the Torrey Buff Quarry.

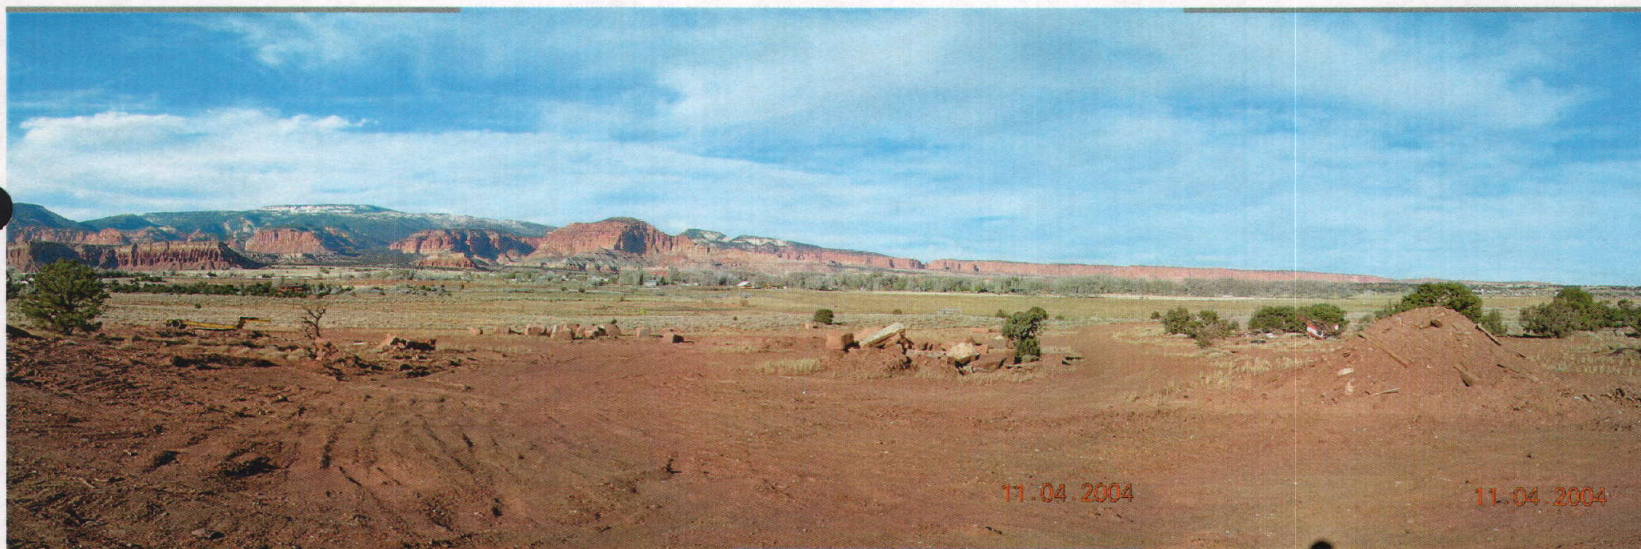
Where the stone has been hauled away, the ground is still disturbed, and it was impossible for me to tell whether these areas are going to be used for future operations. Portions of the areas where stone has been and is being stored area shown in Photos 6 and 7. The operator needs to finish taking away stone from areas that will no longer be used for loading and consolidate all operations as much as possible. I strongly suggest that the disturbed areas then be marked with T-posts to make it clear what is and what is not part of the disturbed area.

Photo 6. A portion of the stone storage area at the Lucero Red Quarry.

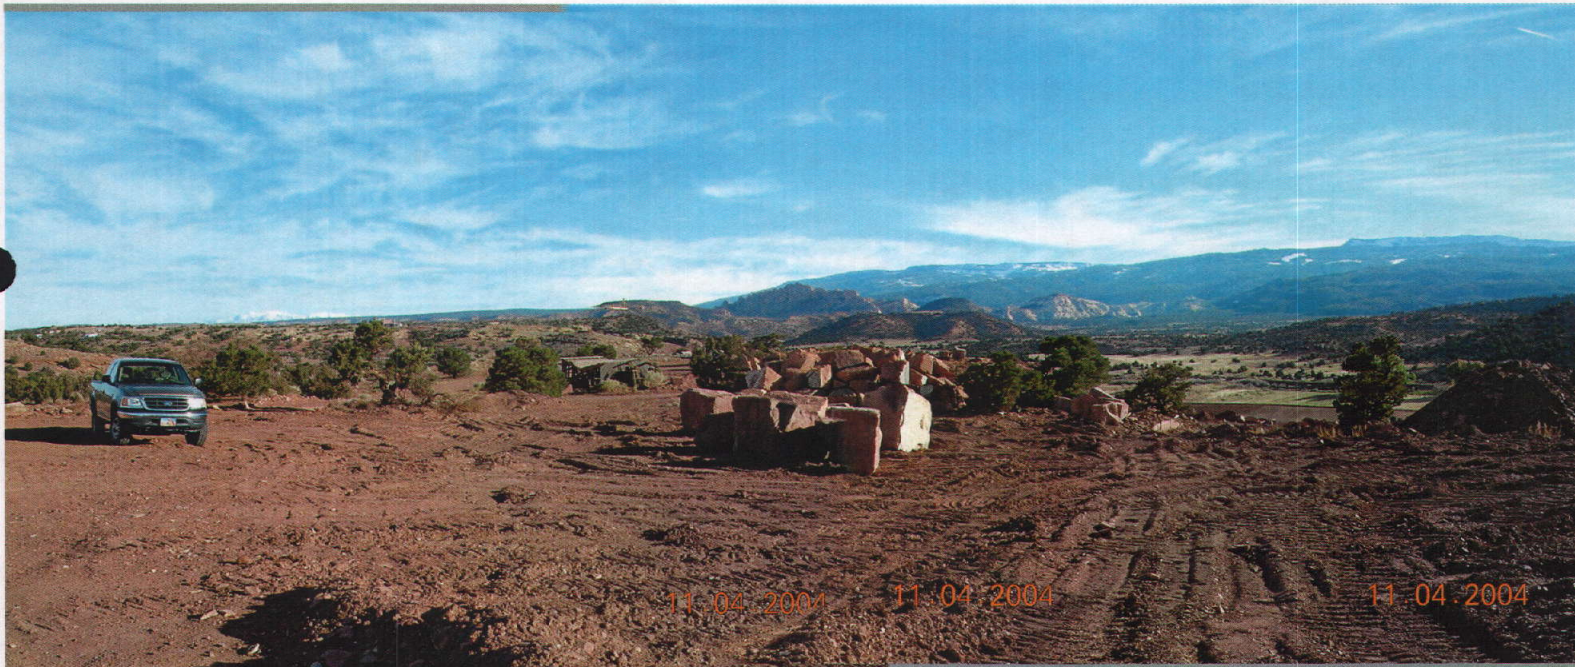
Photo 7. Another view of part of the stone storage area at the Lucero Red Quarry. Although a lot of stones have been removed, quite a few remain.

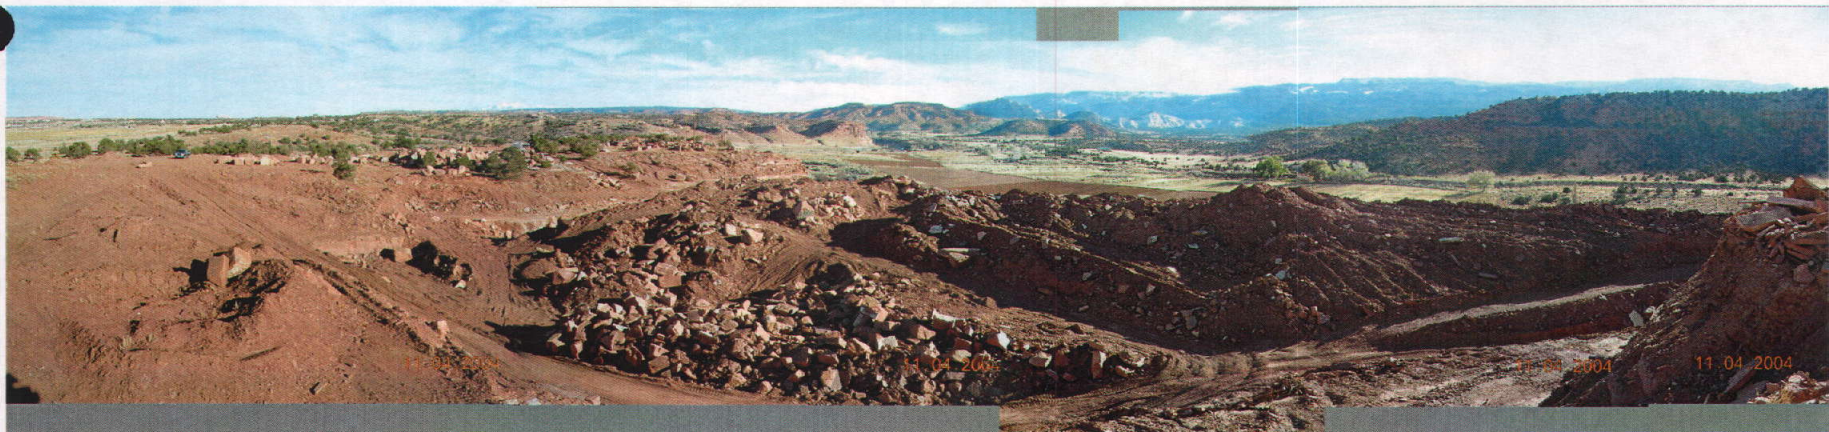
The operator has been doing reclamation work to reduce the sizes of the quarries. At the Lucero Red Quarry, a fair amount of stone has been taken away. There may have been some work to reduce the size of the pit (Photo 8), but, if so, the amount of work has been limited.

Photo 8. The pit at the Lucero Red Quarry. This is a composite of five photos and has some distortion.

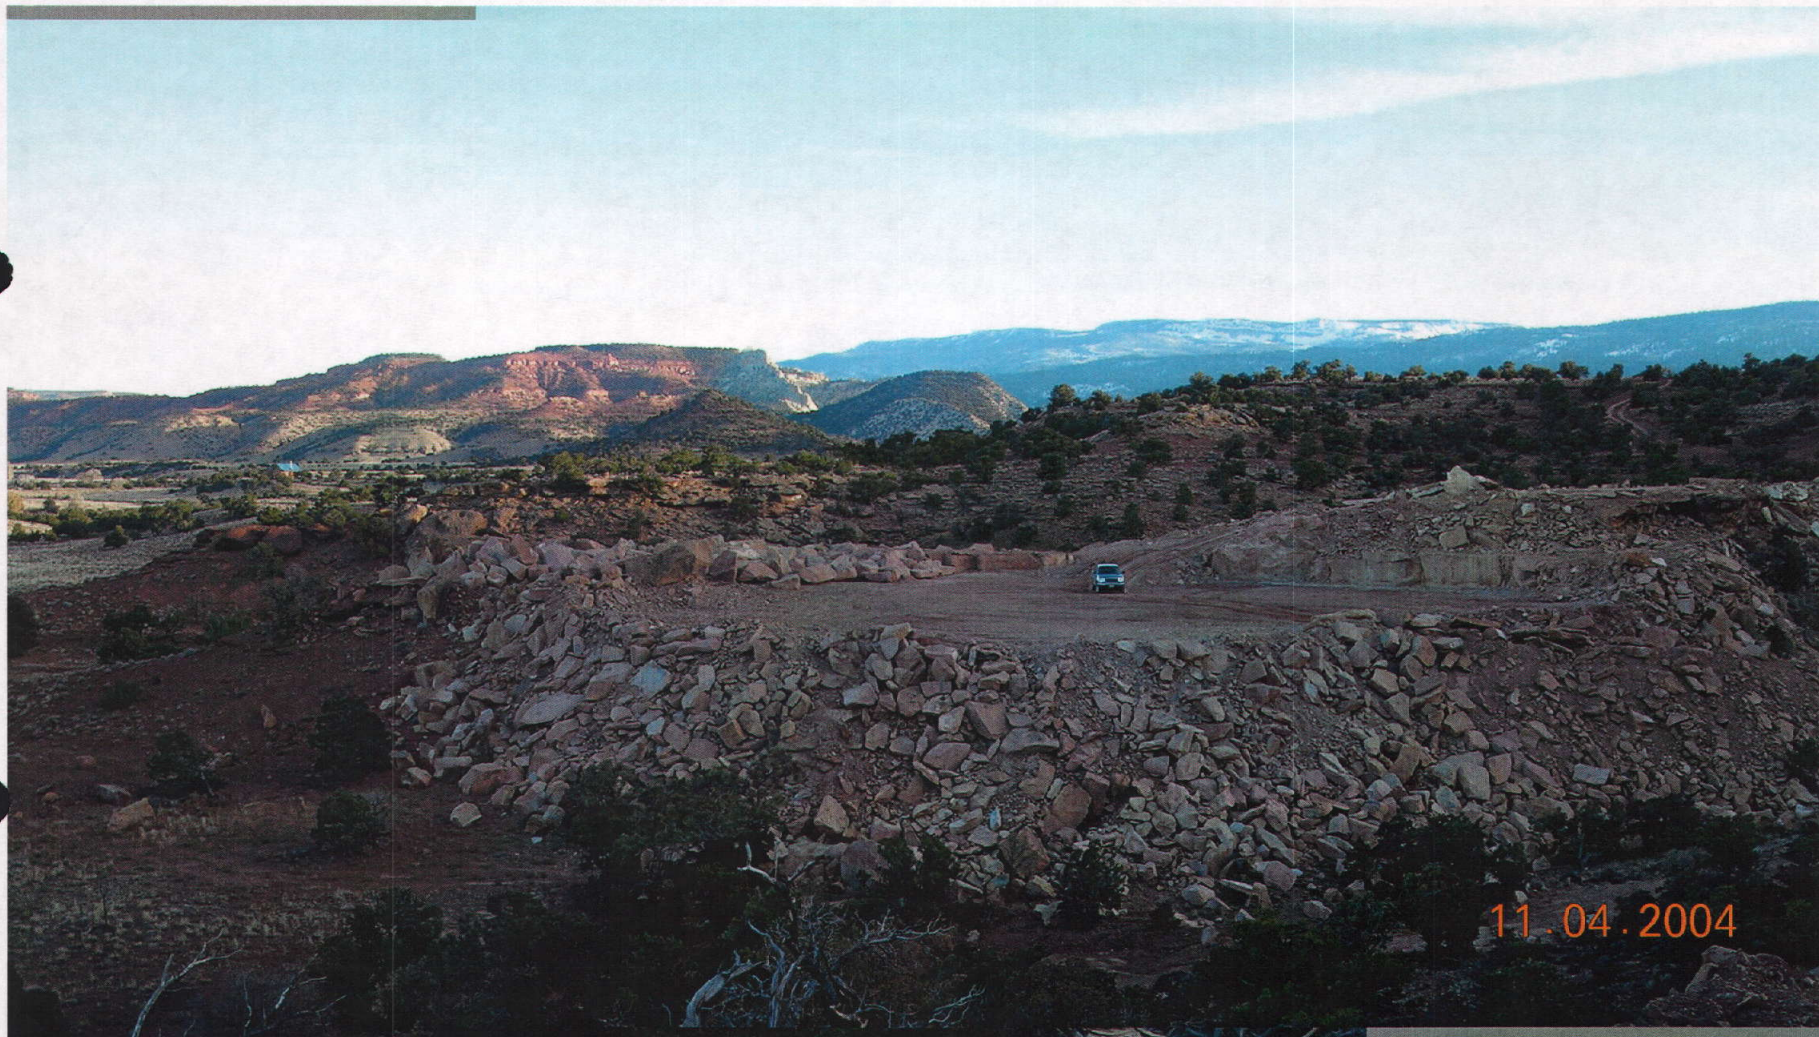
The lower part of the east portion of the buff quarry is shown in Photo 9. As can be seen, this area was graded flat and smooth with rocks pushed over the outslopes. I have mixed feelings whether this area meets grading standards. It does not blend well with surrounding areas, but once vegetation is established, it should provide more forage than some of the adjacent pinyon-juniper slopes. Since the area is so flat and devoid of rocks, it could be used by off-highway vehicles. I have asked the Bureau of Land Management to comment on this grading.

Photo 9. A portion of the regraded area at the Torrey Buff Quarry. Note how flat and smooth the top is. This area should be roughened prior to seeding. In the future, the operator should attempt to blend areas like this into the surrounding terrain and to leave some rock on the surface.

- 1) Notify the Division when grading work is being done so the Division can visit the site and make recommendations.
- 2) Try to blend the disturbed area with surrounding topography. This includes adding a little slope and leaving some rocks on the surface.
- 3) Salvage and spread soil.
- 4) Leave the surface rough.

I spoke with Mr. Pace about preparing the site for seeding. It needs to be left very rough, and seed should be planted as soon as possible after surface preparation. This should happen before December.

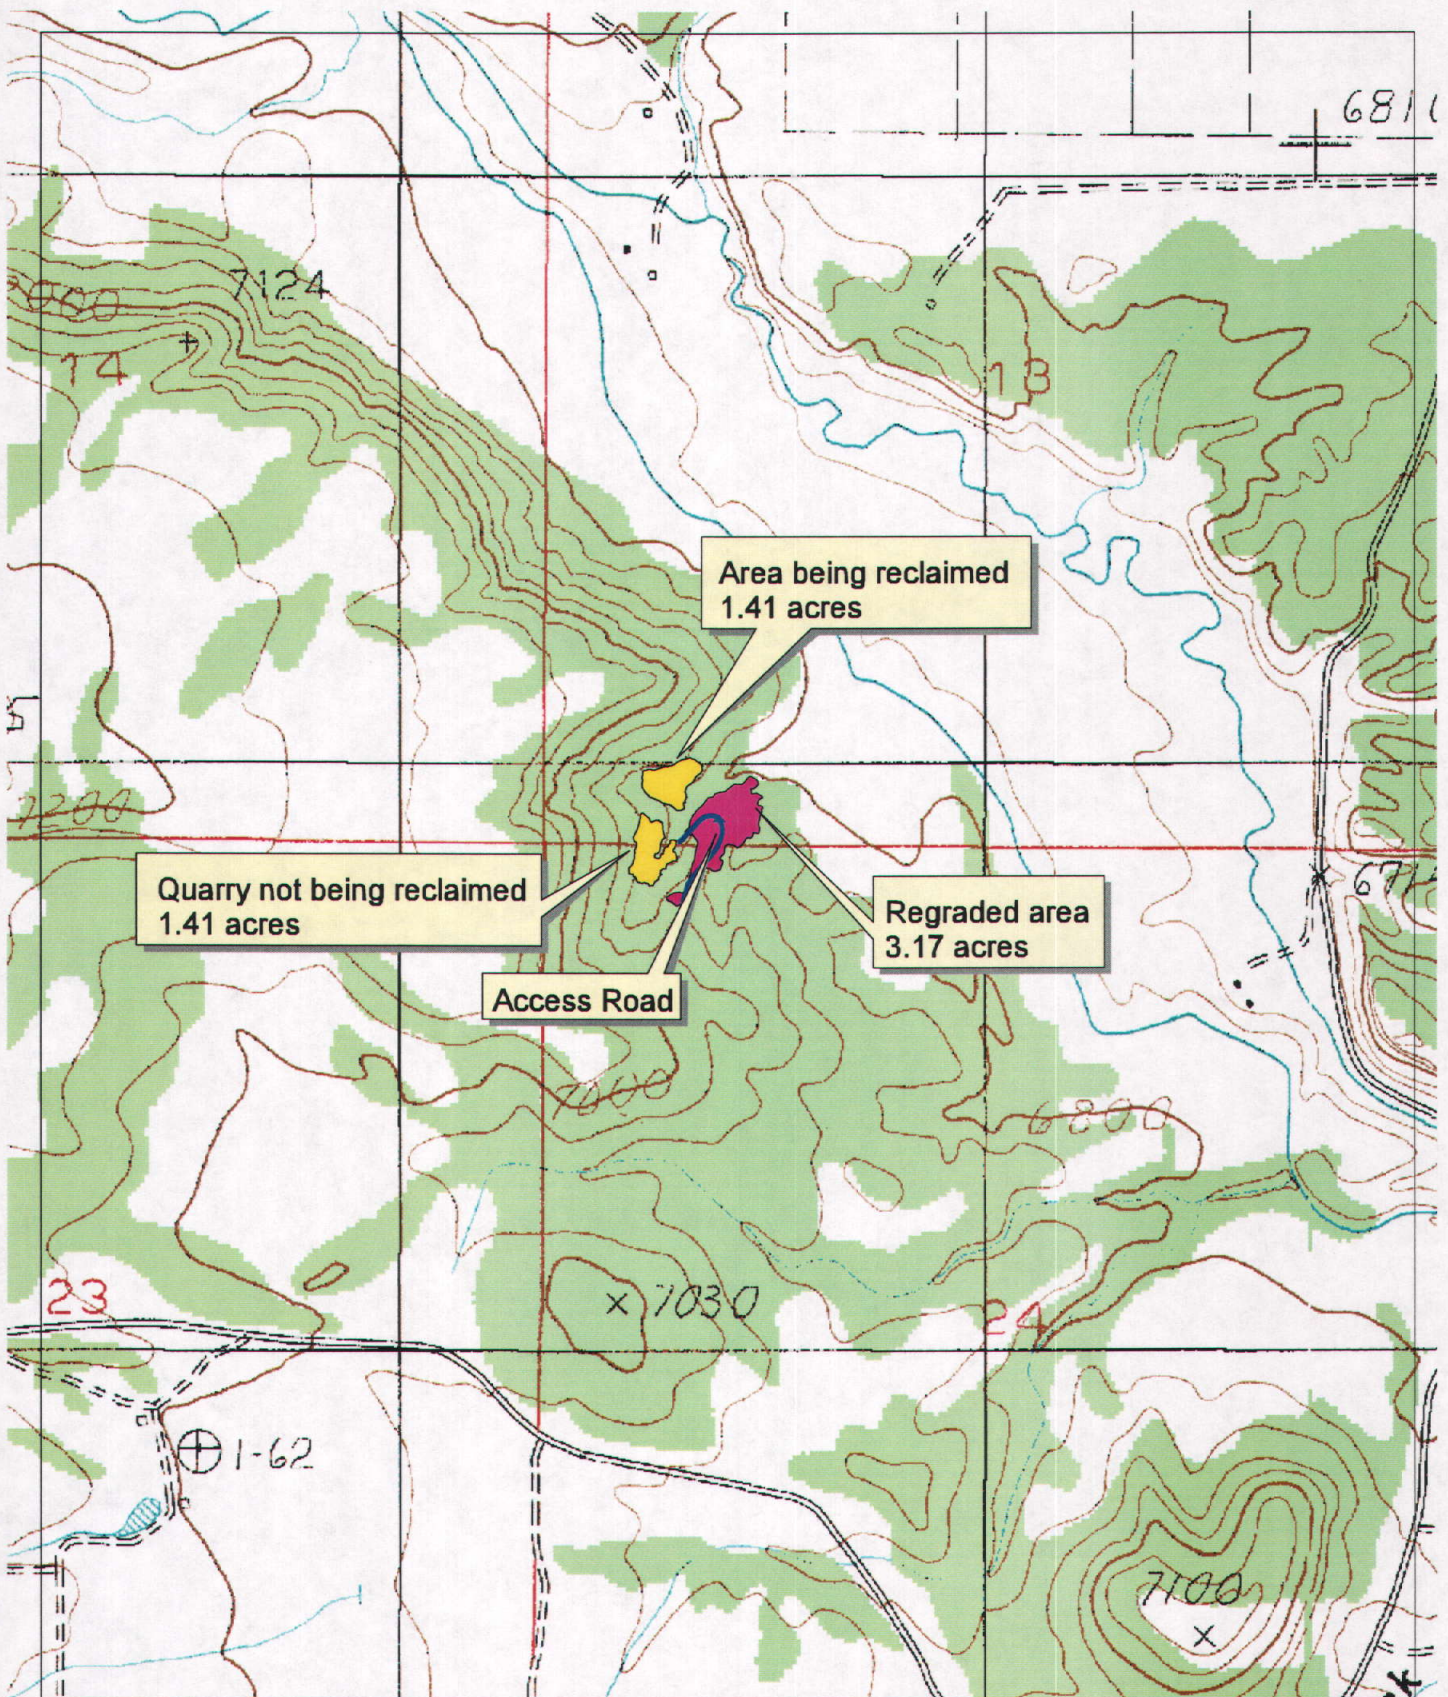
Mine Number: M/055/022
Mine Name: Torrey Buff
Township 29 S Range 4 E Sections 13 and 24 SLBM
Torrey Quad

The east portion of the buff quarry has been regraded but not yet seeded. This area is shown in purple on the attached map. Mr. Pace said he is working to regrade the northwest portion of this quarry and that the operator will continue to mine the southwest portion.

The map attached to this report is a compilation of GPS data gathered during this inspection and during the March 2004 inspection. The purple area has been regraded, and this information was gathered in March. The yellow areas and the road were mapped during the current inspection and

show an area being reclaimed (northwest), an area to be used for future quarrying (southwest),
and the access road.
